INTERIM RCRA FACILITY ASSESSMENT REPORT

SAFETY-KLEEN CORPORATION Jackson, Mississippi

EPA I.D. No. MSD000776765

April 1990

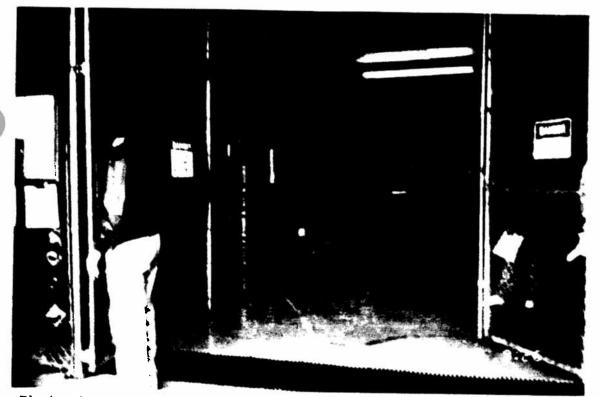
Photo 1. 9:26 am

View of the Container Storage Area (SWMU 1). Only the red drums on the left hand side of the photograph were managing waste at the time of the VSI. All the other drums in the photograph were either storing product or were empty.

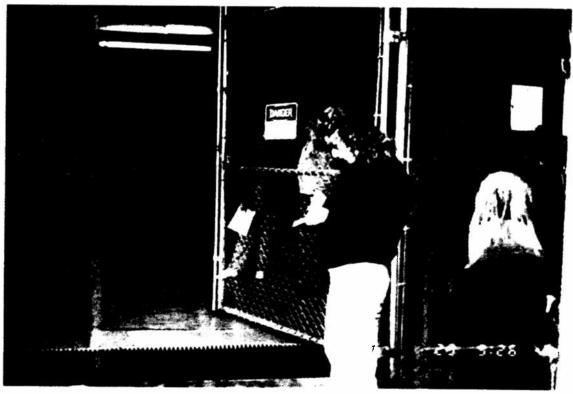
Photo 2. 9:26 am

A second view of SWMU 1. Note that the floor is sealed. The cracks in the foreground appeared to be shallow. The trench and dike interface can be seen in the right foreground.

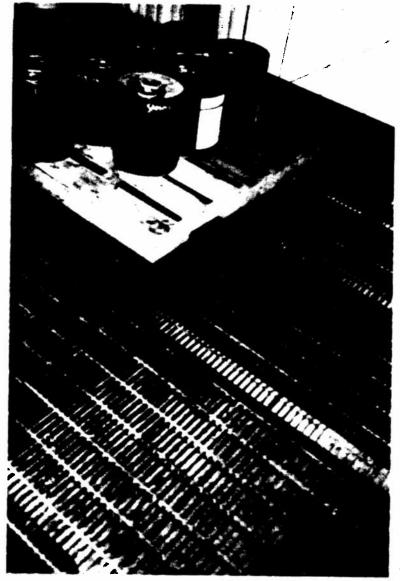
Photo 6.

Interior of the Waste Paint Shelter (SWMU 4). Note the rusty coloration below the grating. This is reportedly due to rainwater in the pan, beneath the unit. The seven cans of paint waste were the total volume wastes managed at the time of the VSI, although some product was also stored here.

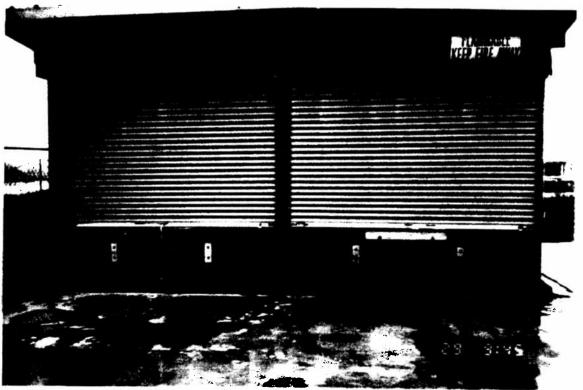
Photo 7. 9:45 am

Exterior view of the Waste Paint Shelter (SWMU 4). Both bay doors may be used at the same time for loading/unloading. Note the metal pan in which the unit rests.

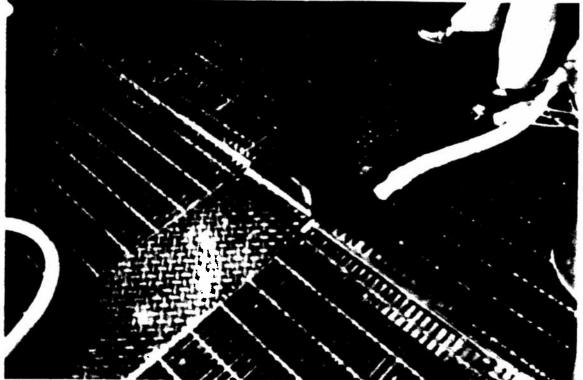
Photo 9. 9:51 am

View of the grating floor of the Work Area (SWMU 3). Any spills would flow through the grating, to the metal pan below. The white tubing at the center is part of the vacuum system used to remove any spills.

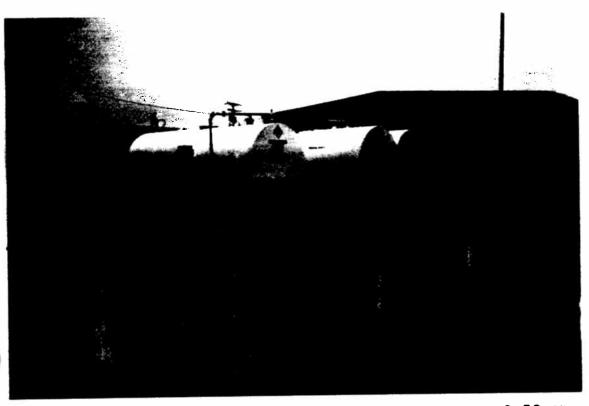
Photo 11. 9:52 am

There was no history of releases from this unit found in the file material, and none were observed during the VSI. However, given the facility's practice of dumping potentially contaminated water from the containment system to nearby soils, a potential for release to soils exists.

Over view of the Tank Management Area (SWMU 2). The tank at the left of the photo is the 8,000 gallon dirty solvent tank, the smaller tank is hidden by it. Note the above ground piping at the left background, and the concrete vault which the tanks rest in.

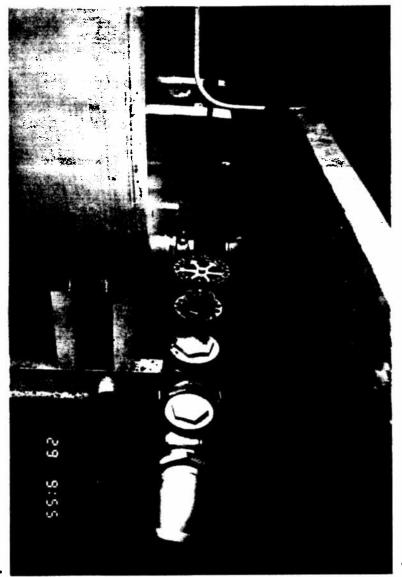
9:55 am Photo 12.

Interior view of the vault. The two valves in the photo are for loading clean solvent (the far valve) and unloading dirty solvent (the near valve). According to the facility representatives, the buckets are placed under the valves to catch incidental spillage.

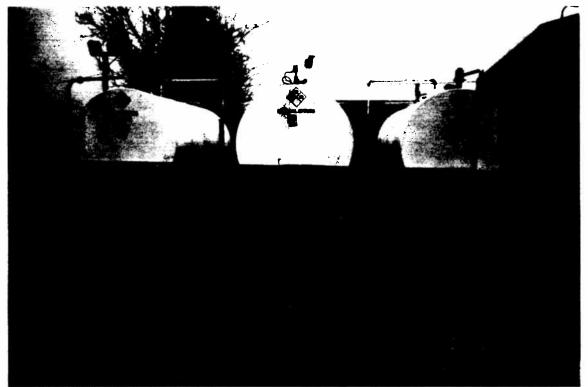
Photo 13. 9:59 am

Another view of the Tank Management Area (SWMU 2).
